HRVATSKO DRUŠTVO ZA VELIKE BRANE

**BRANA PERUĆA**

Ova brošura pripremljena je kao kratak opis radova na sanaciji brane Peruća na rijeci Cetini, i kao poziv HRVATSKOG DRUŠTVA ZA VELIKE BRANE za KONFERENCIJU s istom temom koja će se održati u Splitu u rujnu 1995. godine.

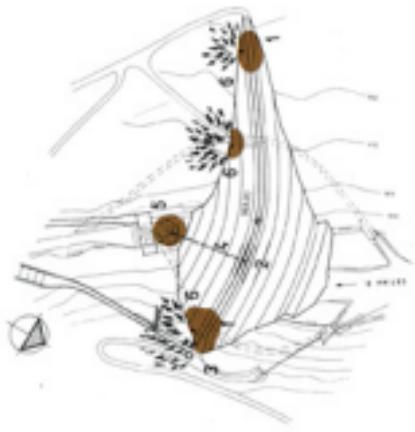
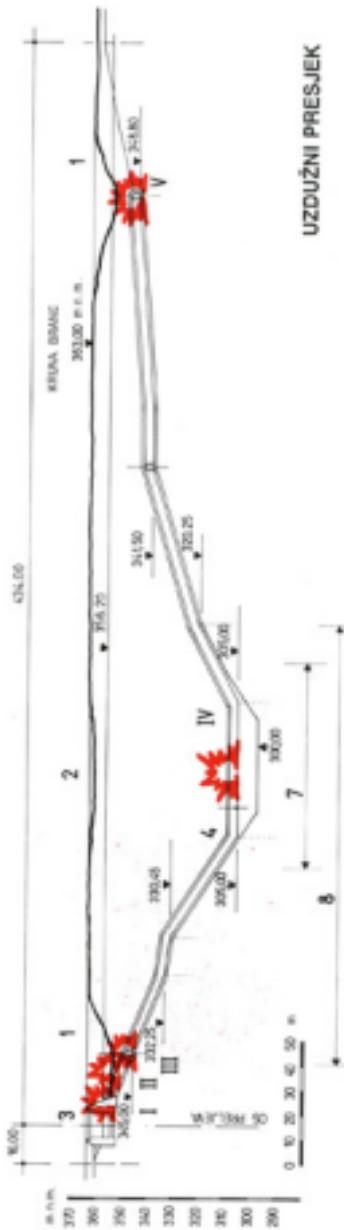
Slika 2. Situacija i uzdužni presjek brane Peruća

Najveća oštećenja nastala su na lijevom kraju brane, gdje je uništen desni zid, zapornica i most preko preljeva, a na kruni brane uz preljev formiran je krater promjera 25-30 m, dubine oko 10 m. U središnjem najvišem dijelu brane, u dužini od oko 50 m došlo je do slijeganja u veličini od oko 2,5-3,0 m. Na desnom kraju brane formiran je krater promjera 25-30 m, dubine 6-7 m. Budući je najveći dio eksploziva postavljen na 3 mjesto u injekcijskoj galeriji, ona je potpuno uništena u dužini od oko 110 m. A na preostalom dijelu u dužini od oko 260 m u betonu su nastale pukotine, ali je u poprečnom presjeku galerija uglavnom zadрžala svoj oblik. Potpuno i teško oštećeno dijelove galerije ispunio je materijal glinene jezgre brane (Sl. 2). Slijeganja brane, prema rezultatima mjerenja koja su obavljana od 29.1.1993. do 10.2.1994., bila su najveća u središnjem najvišem dijelu i iznosila su oko 1,5 m, odnosno oko 2,5% visine brane, od čega se oko 90% desilo u razdoblju pradnjenja jezera od 29.1.1993. do 12.3.1993. godine. Prema tome, ukupna slijeganja središnjeg dijela brane, uključivo inicijalnu prilikom eksplozije, iznosila su 4-4,5 m.

- 1. Krater na desnom i lijevom kraju brane
  - 2. Utečnuće u srednjem dijelu brane
  - 3. Prelev
  - 4. Drenažni ocvod
  - 5. Komadi glineve jezgre
  - 6. Unuterni ulazi u galeriju
  - 7. Potpuno uništena galerija
  - 8. Galerija potpuno ispunjena glinom
- I, II, III, IV, V PREPOSTAVLJENE TOČKE MINIRANJA

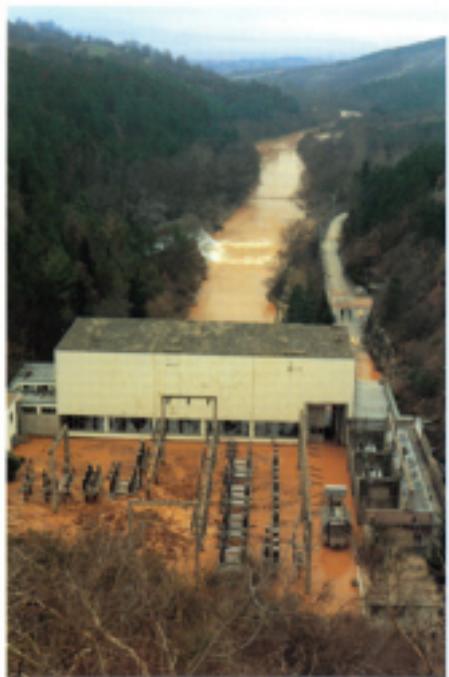
Pogled na strojarnicu i rasklopno postrojenje HE Peruća nakon miniranja brane. Voda je protjecala kroz razrušenu injekcijsku galeriju i drenadni odvod na rasklopno postrojenje iznoseći komade glinene jezgre promjera i do 0,50 m

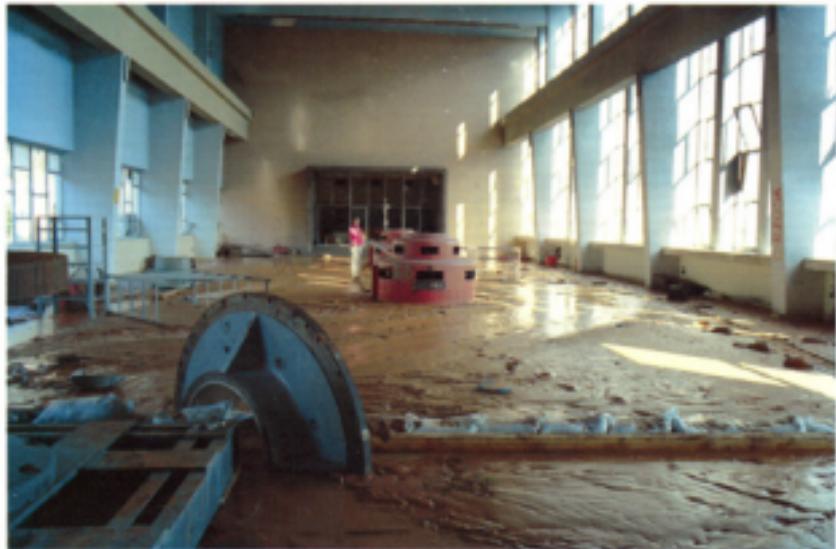
Unutrašnjost strojarnice HE Peruća kojoj je pod pokriven slojem glinovitog materijala debeline i do 0,50 m

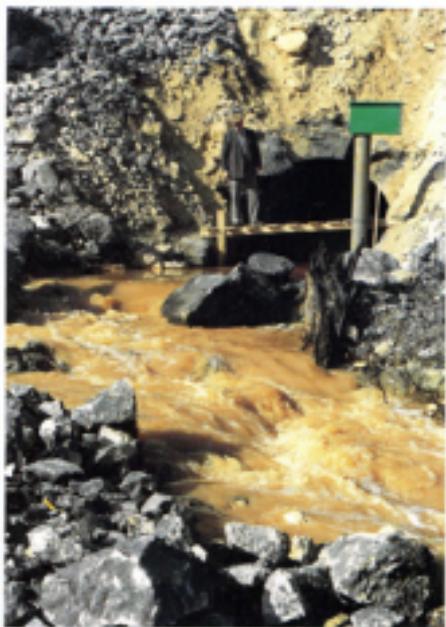
Iz injekcijske galerije voda je istjecala kroz pristupni tunel u količini od oko 600 l/s

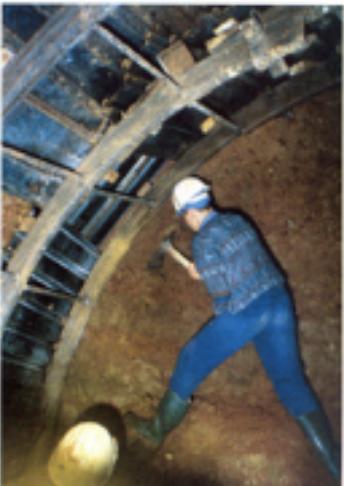
Djelomično razorena injekcijska galerija s nataloženim glinem materijalom

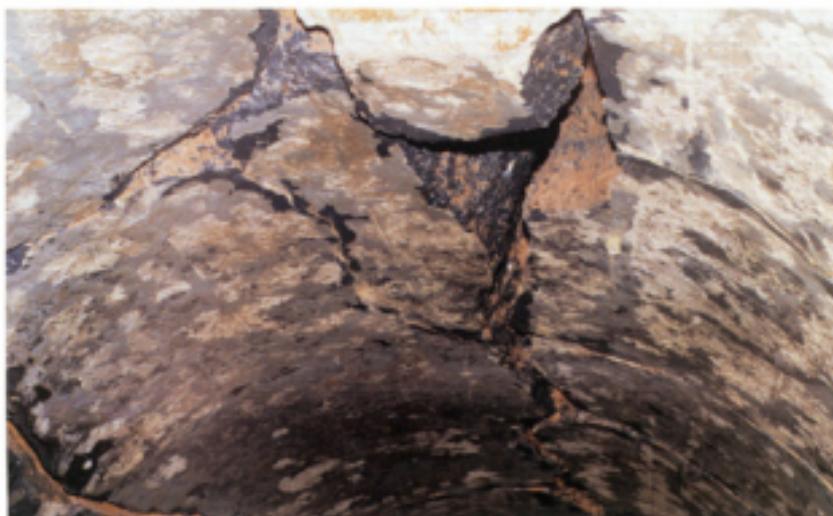
#### Pukotine u betonu svoda galerije

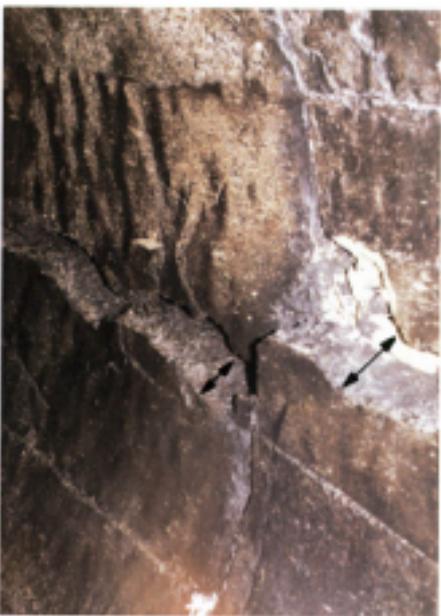
Nizvodni pomak betonskog svoda galerije od oko 15-20 cm

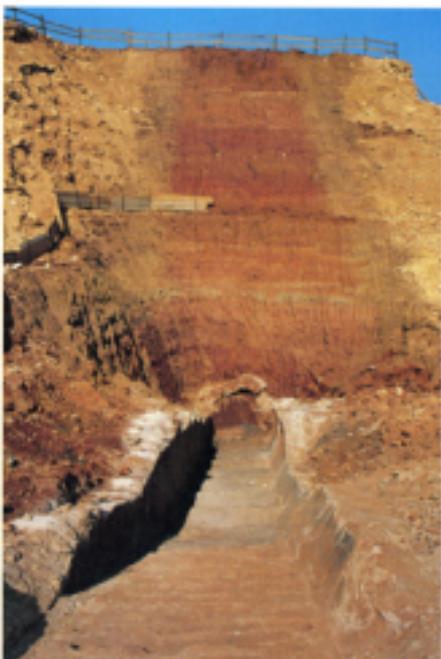
Završeni iskop lijevog kraja brane

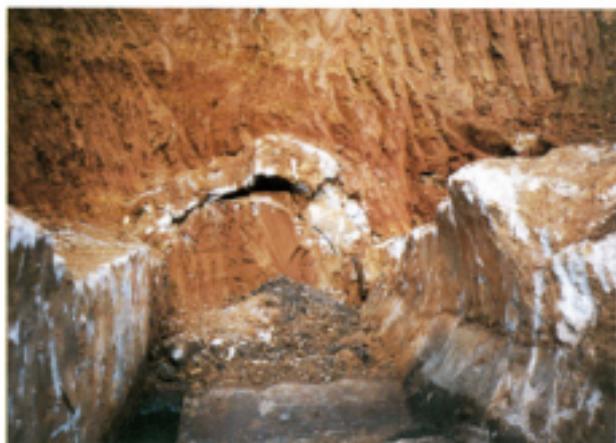
Najniži dio iskopa  
lijevog kraja brane,  
kota 329 m n.m., s  
razrušenom  
galerijom potpuno  
ispunjenoj glinom

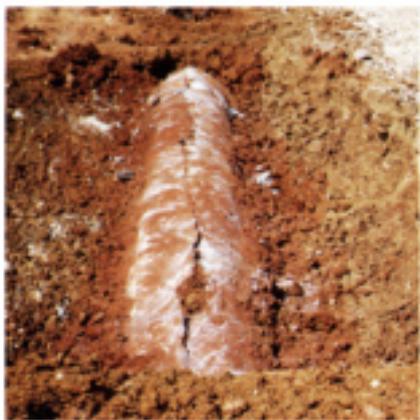
Dio djelomično razrušene galerije na desnom kraju brane

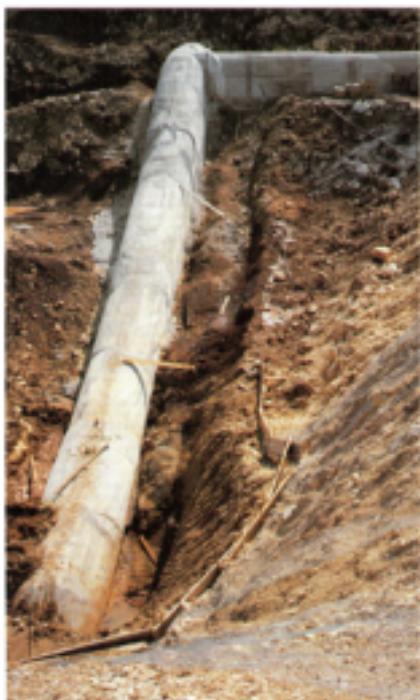
Novoizgrađena galerija s pristupnim tunelom na lijevom kraju brane

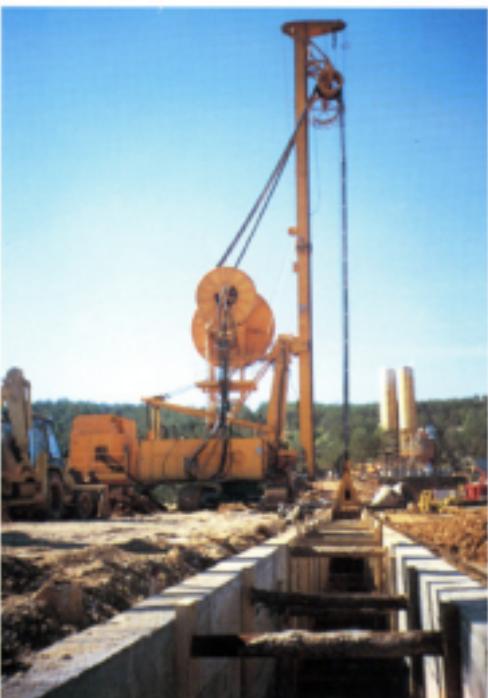
Izvedba dijafrigne od plastičnog betona u glinenoj jazgi brane: iskop hidrauličkim rezacem

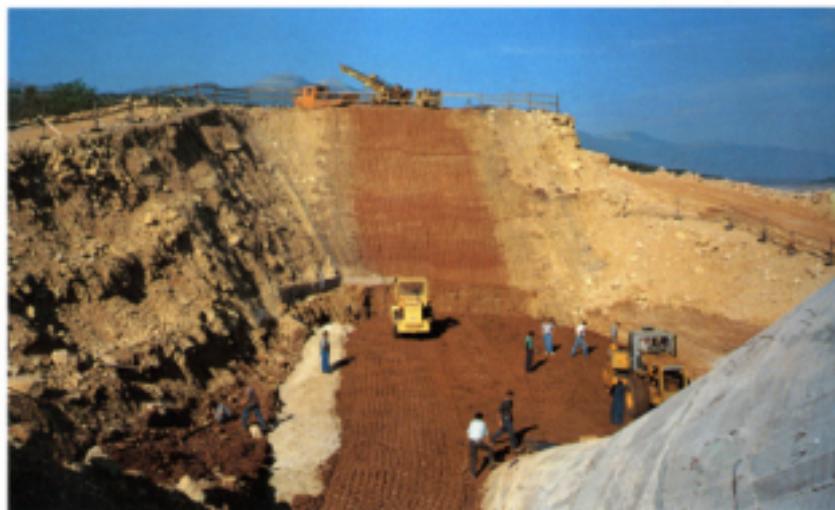
Nasipavanje lijevog kraja brane, kota 338,50 m n.m.

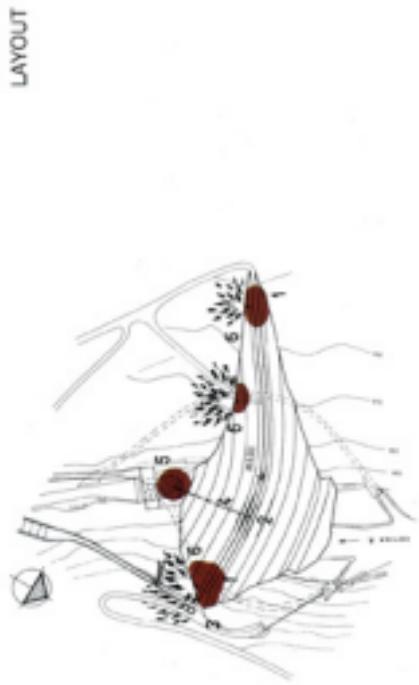
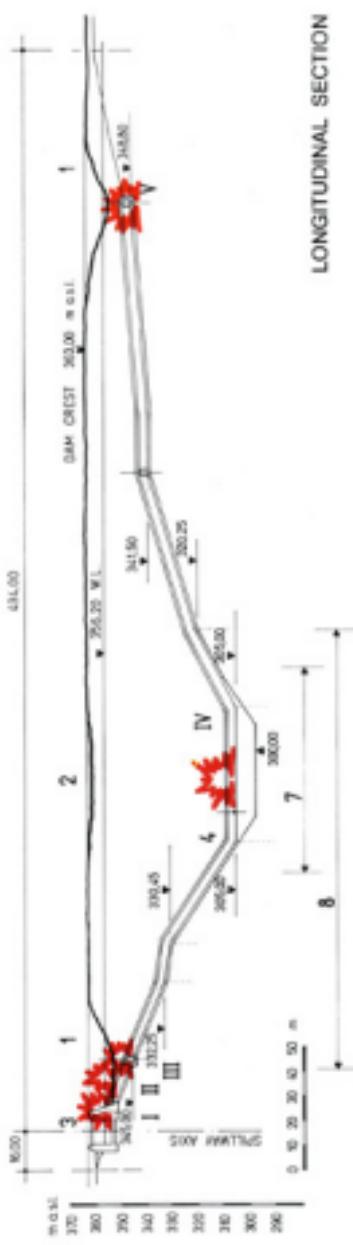
Figure 2. Perúca dam layout and longitudinal section

The major damage was suffered by the left dam end, where the right wall, spillway gate and the access spillway bridge were destroyed, and the crater 25-30 m in diameter and about 10 m deep was formed in the dam crest by the spillway. The highest central dam section, some 50 m long, subsided for approximately 2.5 - 3.0 m. A crater 20-25 m in diameter and 6-7 m deep developed on the right dam end. Since the majority of the explosive was set in three points in the grouting gallery, the gallery was completely destroyed in approximately 110 m long stretch. The concrete cracks appeared on the remaining 260 m; however, it generally retained its cross-section shape. The completely and heavily damaged gallery sections were filled with the clay core material (Fig. 2). According to the results of measurements carried out from January 29, 1993 to February 10, 1994, the settlement was the most intensive in the highest central dam section, namely 1.5 m or 2.5% of the dam height; 90% of the settlement occurred during the reservoir discharge from January 29, 1993 to March 12, 1993. Thus, the total central dam section settlement, including the initial settlement during the explosion, was 4-4.5 m.

- KEY**
1. Craters on the right and left dam ends
  2. Subsidence in the central dam section
  3. Spillway
  4. Drainage outlet
  5. Chunks of clay core
  6. Caved-in gallery entrances
  7. Gallery completely destroyed
  8. Gallery completely filled with clay
- I, II, III, IV, V = ASSUMED BLASTING POINTS

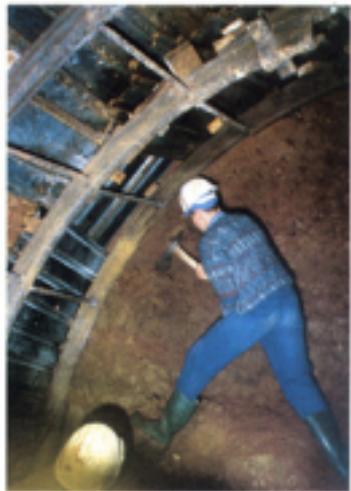
*Reconstruction of the completely destroyed gallery: excavation of clayey material mixed with the concrete blocks from the gallery carried out under the protection of steel arches and concrete panels.*

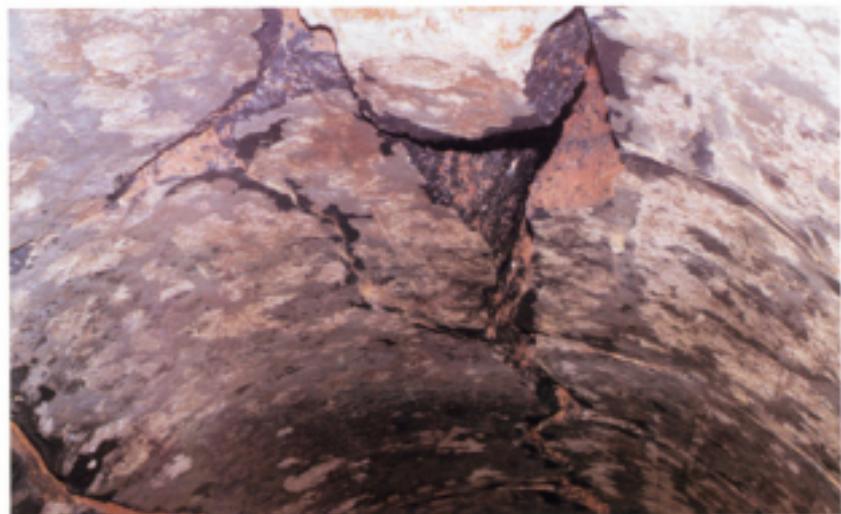
*Cracks in the gallery arch concrete.*

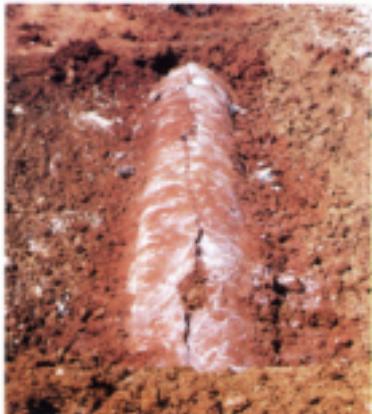
*Segment of partly destroyed gallery in the right dam end.*

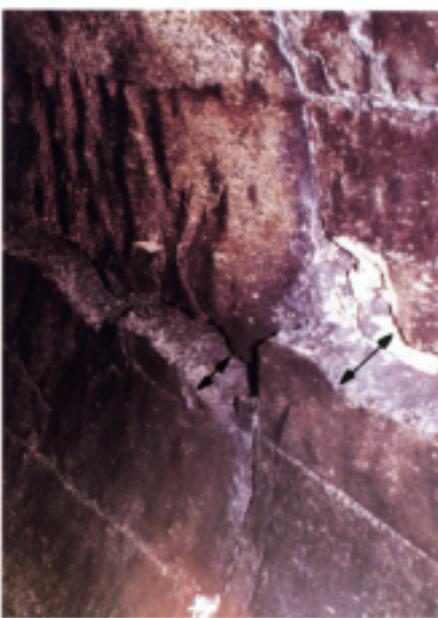
*Downstream displacement of concrete gallery arch for about 15-20 cm.*

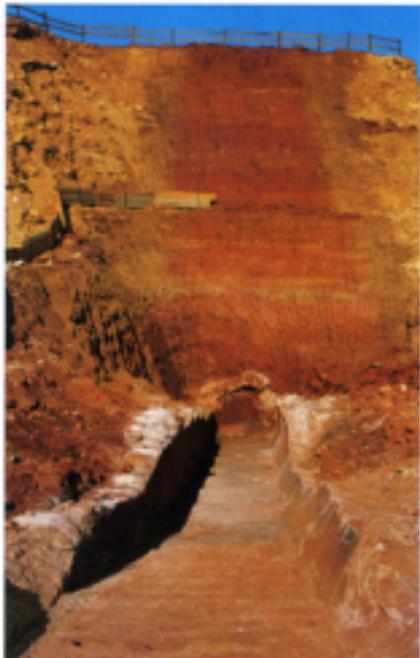
*Final excavation in the left dam end.*

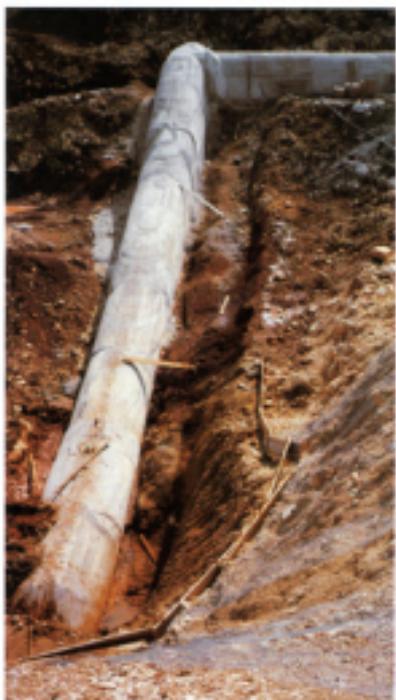
*The rebuilt gallery with the access funnel in the left dam end.*

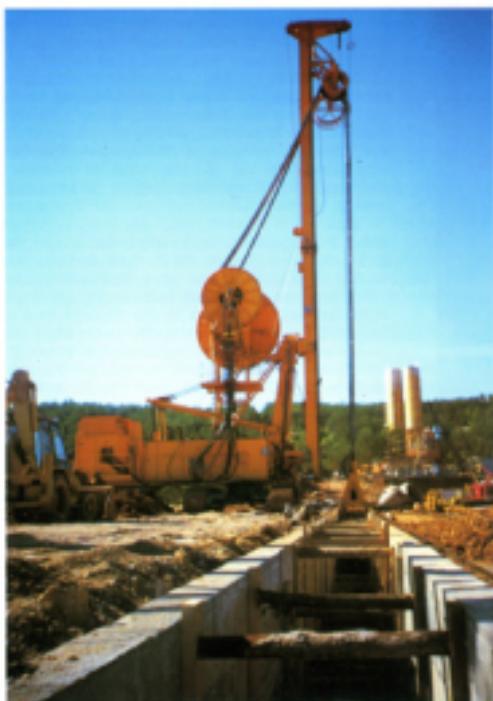
*The plastic concrete cut-off wall construction in the dam clay core - excavation by hydraulic trench cutter.*

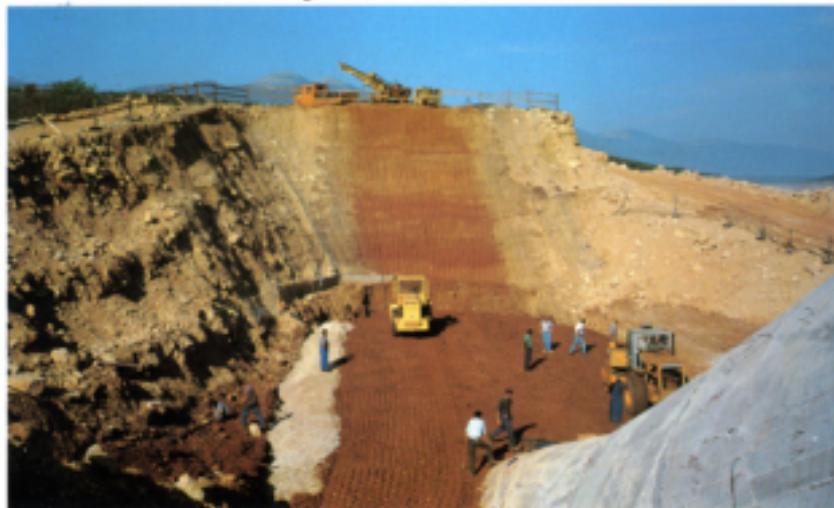
*Backfilling the left dam end, El. 338.50 m a.s.l.*
