# PERUĆA DAM

CROATIA

REMEDIATION

## CETINA HYDROPOWER SCHEME

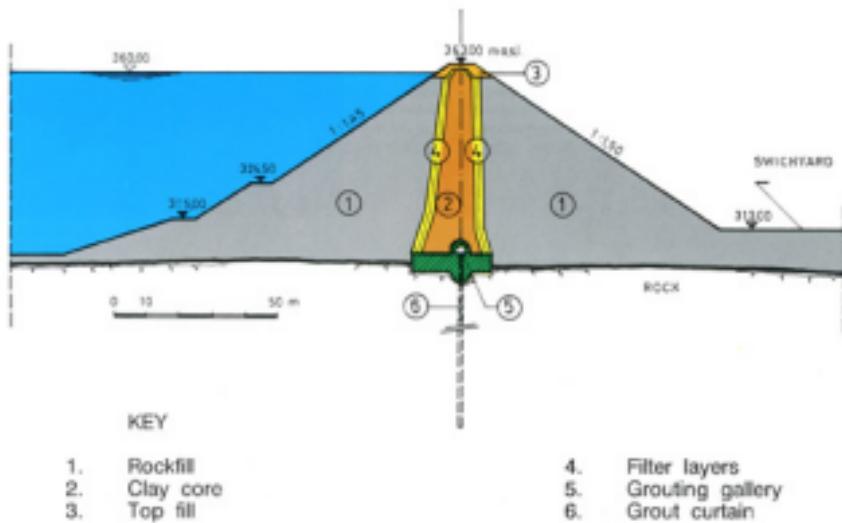
Figure 1. Dam cross-section

The dam is of rockfill type, with zoned cross-section consisting of centrally placed clay core, filter layers and crushed stone upstream and downstream shells. The dam is 63 m high and 450 m long in crest. Since the dam is founded on the permeable limestone the watertightness of the dam profile and the reservoir is achieved by construction of 200 m deep and 1,600 m long grout curtain with total surface area of 260,000 m<sup>2</sup> (Fig.1).

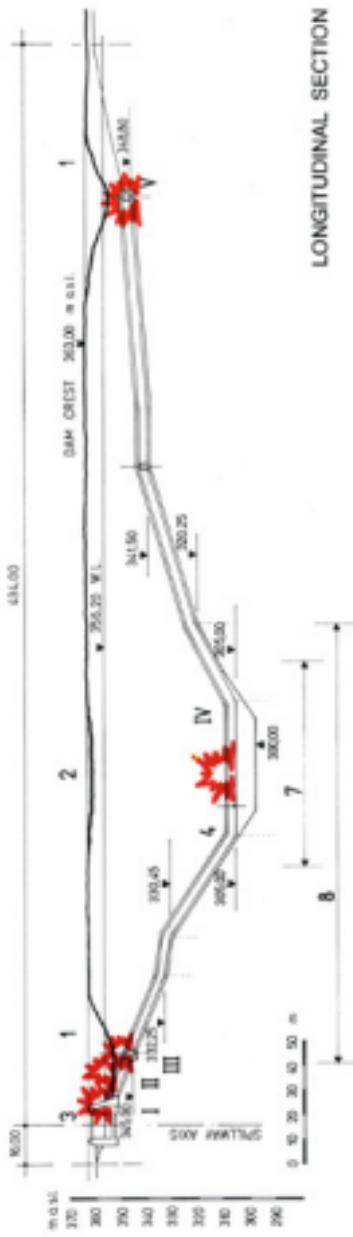
Figure 2. Penúca dam layout and longitudinal section

The major damage was suffered by the left dam end, where the right wall, spillway gate and the access spillway bridge were destroyed, and the crater 25-30 m in diameter and about 10 m deep was formed in the dam crest by the spillway. The highest central dam section, some 50 m long, subsided for approximately 2.5 - 3.0 m. A crater 20-25 m in diameter and 6-7 m deep developed on the right dam end. Since the majority of the explosive was set in three points in the grouting gallery, the gallery was completely destroyed in approximately 110 m long stretch. The concrete cracks appeared on the remaining 260 m; however, it generally retained its cross-section shape. The completely and heavily damaged gallery sections were filled with the clay core material (Fig. 2). According to the results of measurements carried out from January 29, 1993 to February 10, 1994, the settlement was the most intensive in the highest central dam section, namely 1.5 m or 2.5% of the dam height; 90% of the settlement occurred during the reservoir discharge from January 29, 1993 to March 12, 1993. Thus, the total central dam section settlement, including the initial settlement during the explosion, was 4-4.5 m.

#### I, II, III, IV, V = ASSUMED BLASTING POINTS

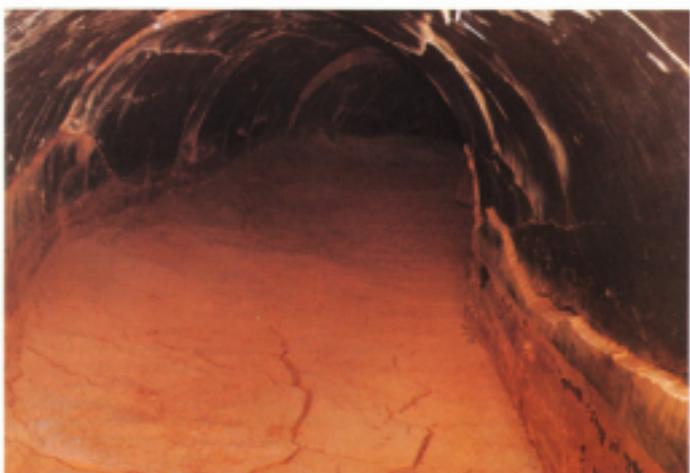
*Počiniški destruktivni grouting gallery with deposited clay.*

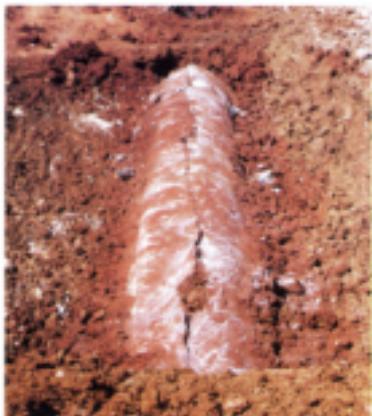
*Downstream displacement of concrete gallery arch for about 15-20 cm.*

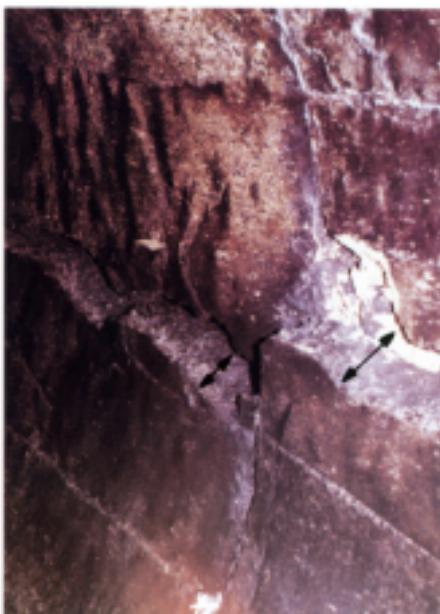
*Segment of partly destroyed gallery in the right dam end.*

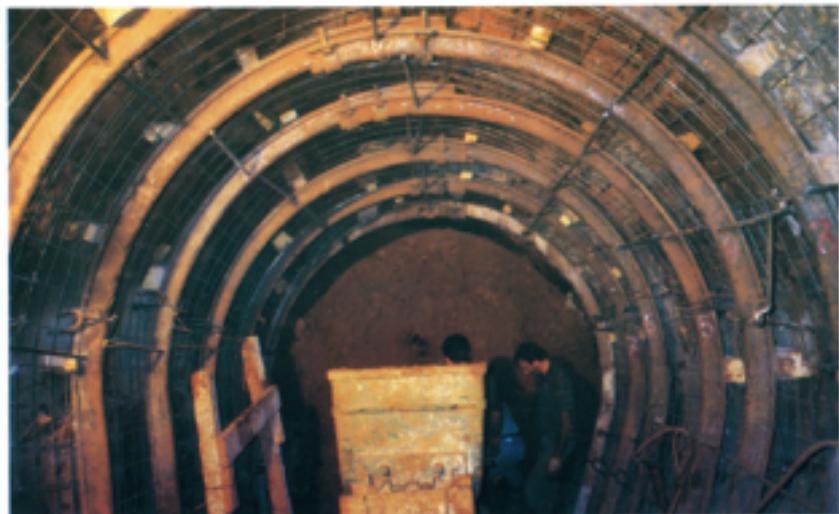
*Reconstruction of partly destroyed gallery with steel arches and shotcrete layer.*

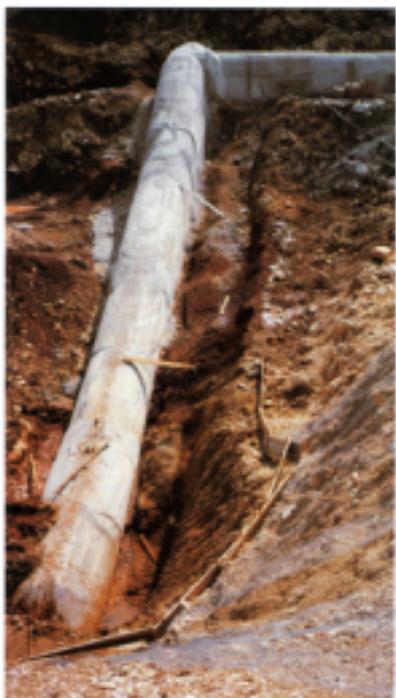
*The rebuilt gallery with the access funnel in the left dam end.*

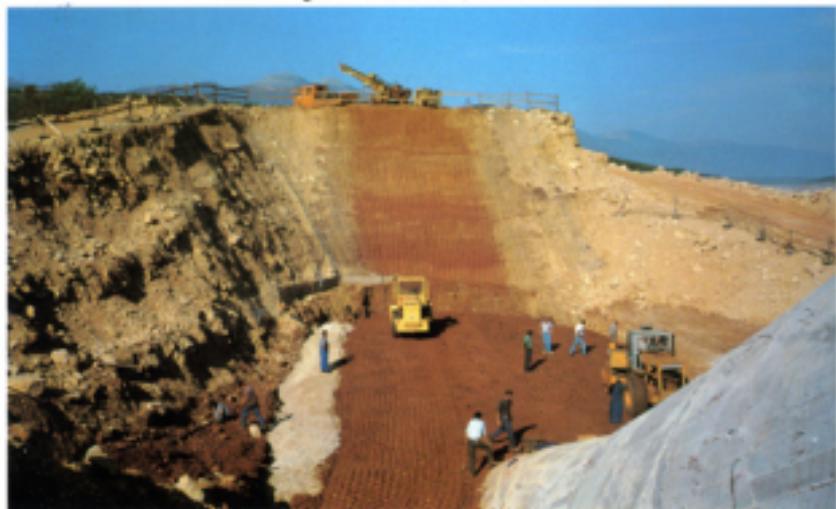
*Backfilling the left dam end, El. 338.50 m a.s.l.*
