# PERUĆA DAM

CROATIA

REMEDIATION

## CETINA HYDROPOWER SCHEME

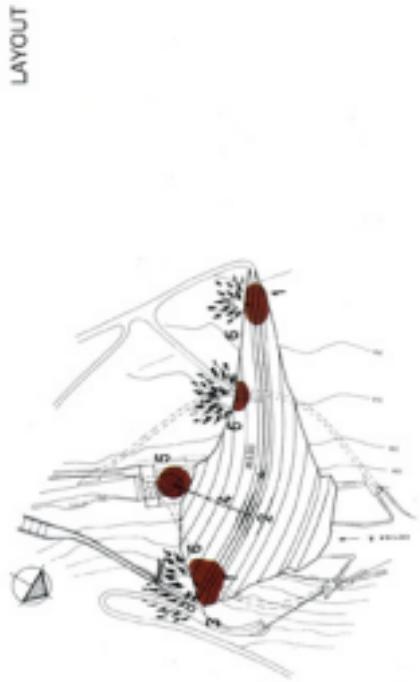
Figure 2. Penúca dam layout and longitudinal section

The major damage was suffered by the left dam end, where the right wall, spillway gate and the access spillway bridge were destroyed, and the crater 25-30 m in diameter and about 10 m deep was formed in the dam crest by the spillway. The highest central dam section, some 50 m long, subsided for approximately 2.5 - 3.0 m. A crater 20-25 m in diameter and 6-7 m deep developed on the right dam end. Since the majority of the explosive was set in three points in the grouting gallery, the gallery was completely destroyed in approximately 110 m long stretch. The concrete cracks appeared on the remaining 260 m; however, it generally retained its cross-section shape. The completely and heavily damaged gallery sections were filled with the clay core material (Fig. 2). According to the results of measurements carried out from January 29, 1993 to February 10, 1994, the settlement was the most intensive in the highest central dam section, namely 1.5 m or 2.5% of the dam height; 90% of the settlement occurred during the reservoir discharge from January 29, 1993 to March 12, 1993. Thus, the total central dam section settlement, including the initial settlement during the explosion, was 4-4.5 m.

#### I, II, III, IV, V = ASSUMED BLASTING POINTS
